ADVANCED COMPOSITE STABILIZER FOR BOEING 737 AIRCRAFT

(NASA-CR-157639) ADVANCED COMPOSITE
STABILIZER FOR BOEING 737 AIRCRAFT
Quarterly Technical Progress Report, 19 Apr.
- 18 Jul. 1978 (Boeing Commercial Airplane
Co., Seattle) 150 p HC AC7/MF A01 CSCI 11D G3/24 19731

FOURTH QUARTERLY TECHNICAL PROGRESS REPORT
19 APRIL 1978 THROUGH 18 JULY 1978

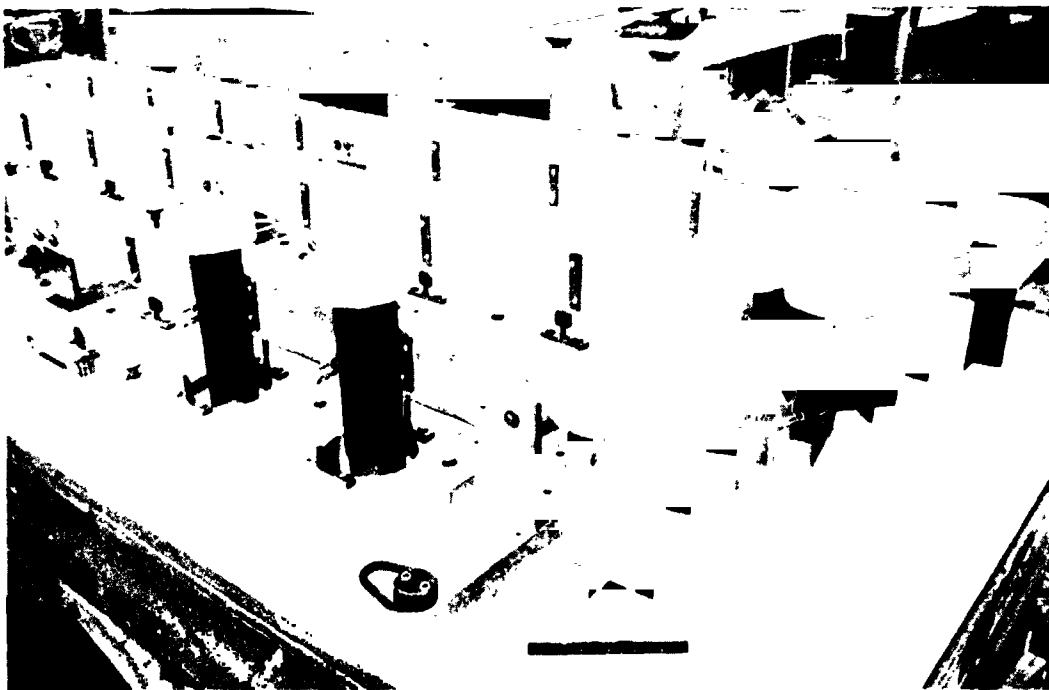
- Spar chord crippling (Test No. 7)
Detail fabrication and assembly complete, (Figures 4-9 and 4-10).
- Skin-to-rib joints (Test No. 9)
Detail fabrication and assembly complete.
- Skin panel (Test No. 10)
Tool fabrication 30% complete.
- Spar shear web (Test No. 11)
Detail fabrication and assembly complete.
- Spar lug (Test No. 12)
Detail fabrication complete, Assembly 50% complete (Figures 4-11 through 4-16).
- Sonic test box (Test No. 20)
In Tool and Production Planning.
- Stub box (Test No. 21)
Detail fabrication complete. Assembly 50% complete.

Figure 4-10. Spar Chord Crippling (Test No. 7), Showing Completed Specimens
